TECHNICAL CASE STUDY: SOLAR POWER GENERATION /INVERTER

SOLAR PLANT INVERTER: MANGLORE /JULY 21

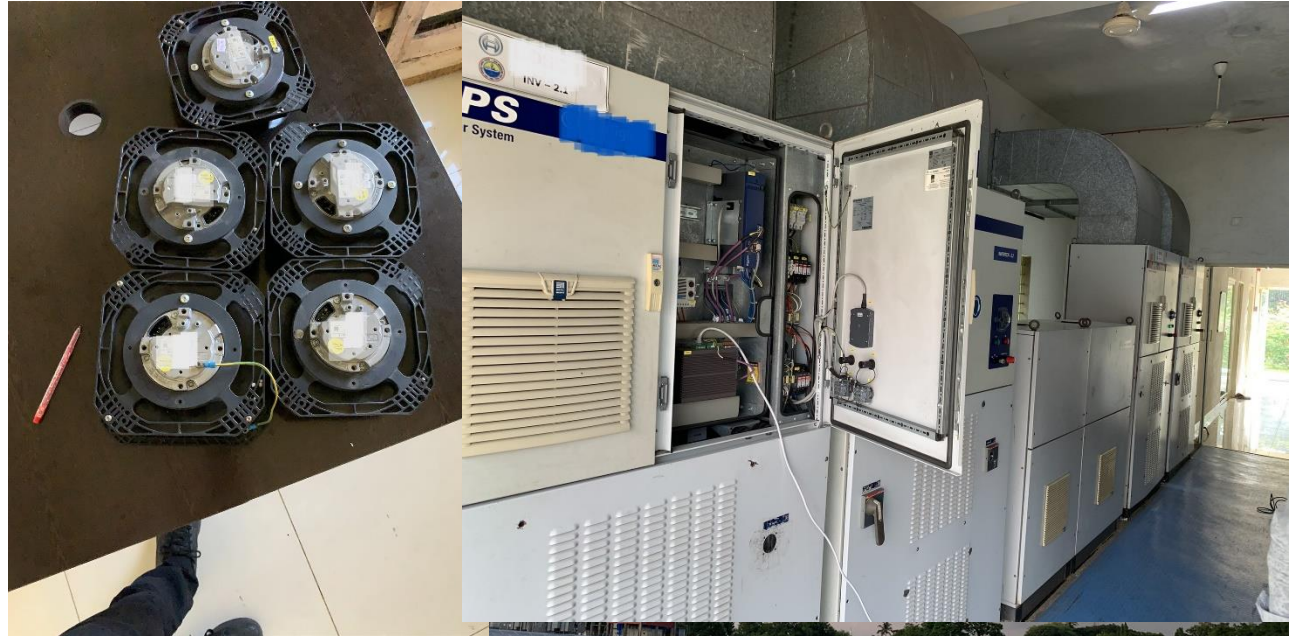
FAN KEEP ON FAILING TOTAL 40 NOS : CHALLENGES

- Failed fan dimensions should be matched to fit inside inverter
- Controlling methodology was unknown.
- We can't do any alteration in Inverter
- There was no option to do experimentation as every day the penalties were imposed to operator
- Fan capacity need to be matched with dimensional limitation
